Ticking Noise from Front Axle When Cornering

F22 (2 Series Coupe)

F30 (3 Series Sedan)

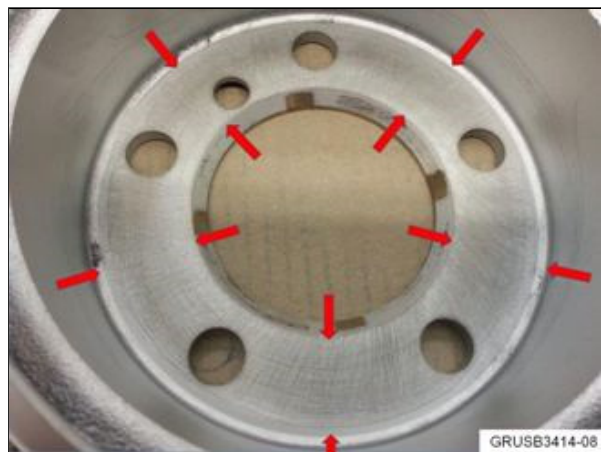
The customer may complain of a ticking noise from the front axle when cornering, maneuvering, parking or pulling away from a parking space. The noise can be heard as a light metallic ticking from the front outer cornering wheel.

Movement between the brake disc and wheel bearing hub.

Sand the hub surface on the **brake disc** to the wheel bearing hub using 80-grit sandpaper.

Sand the surface in a radial motion (inside to outside around the surface). Clean the wheel bearing hub surface.

Do not sand the hub surface.
Do not apply any type of lubricant to the components surface (wheel bearing or brake disc).
