Technical Service Bulletin

35 Gearbox warning light on (DTCs P179E00, P179F00, P0700, P060A)

35 16 22 2032211/4 April 18, 2016. Supersedes Technical Service Bulletin Group 35 number 16-19 dated January 11, 2016 for reasons listed below.

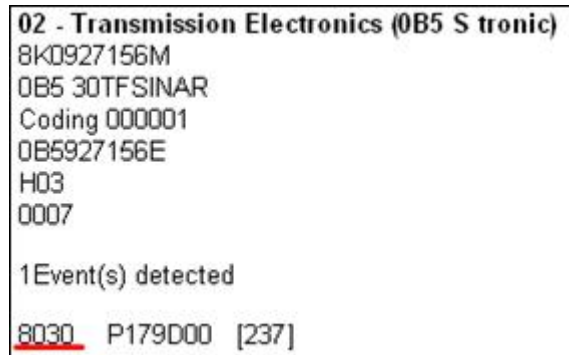
The DFCC is the 4-6 digit code that is typically listed before the fault code (Figure 1).

Figure 1. DFCC 4-6 digit code listed before the fault code, underlined in red.

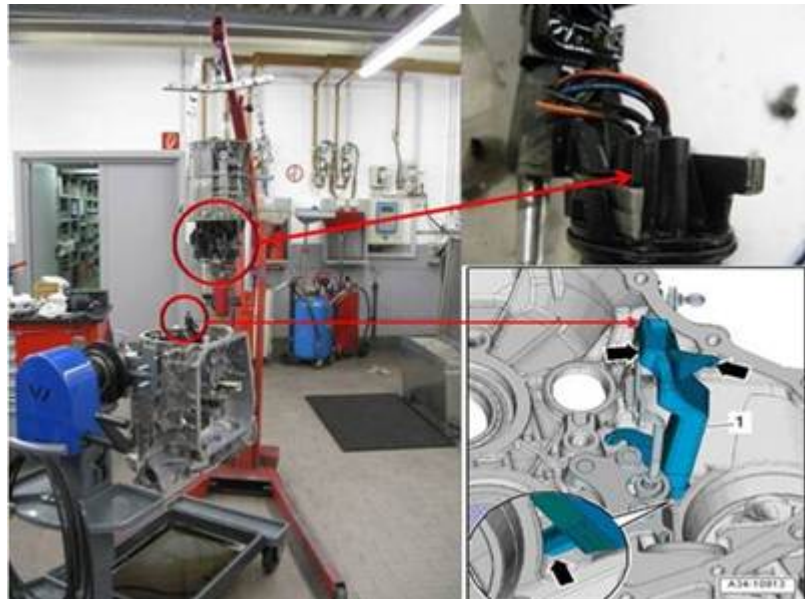
Tip: Use caution when lifting or lowering intermediate housing to avoid damage to components (Figure 2).

Figure 2. Caution points: drip tray and sensor module connector.

If the *Condition* matches exactly, replace the G676 sensor module with circuit board by following instructions in *Elsa >> Repair manual >> Transmission >> S Tronic Transmission Internal Components >> 35 Gears, Shafts >> Removal and Installation >> Sensor Module with Transmission Input Speed Sensor -G612-, -G632-, -G676- and Circuit Board 3.*

When replacing the sensor module, its wiring loom must also be replaced.
