07-006/17 - A/C BLOWS WARM AIR DUE TO REFRIGERANT LEAK

TSB NUMBER: 07-006/17

05/26/2017

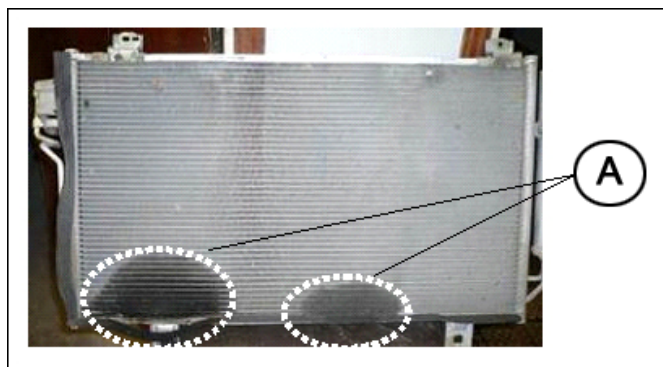
- Condenser corrosion, causing a refrigerant leak (A).

A. Repair Procedure (Condenser corrosion, causing a refrigerant leak)

1. Replace the condenser. Refer to MGSS online Workshop Manual [CONDENSER REMOVAL/INSTALLATION \[SKYACTIV-G 2.0\]](#).

NOTE: When replacing the condenser, add compressor oil of approximately 40 ml [40 cc, 1.4 fl oz]. Refer to MGSS online Workshop Manual [REFRIGERANT CHARGING](#).

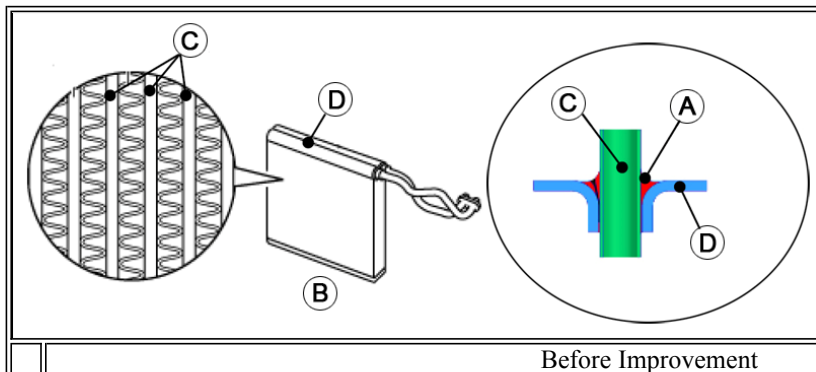
- Improper brazing (A) of the evaporator (B), causing a refrigerant leak from the joint between the tubes (C) and the header (D).

B. Repair Procedure (Improper brazing of the evaporator, causing a refrigerant leak)

1. Replace the A/C evaporator. Refer to MGSS online Workshop Manual:

NOTE: When replacing the evaporator, add compressor oil of approximately 40 ml [40 cc, 1.4 fl oz]. Refer to MGSS online Workshop Manual [REFRIGERANT CHARGING](#).

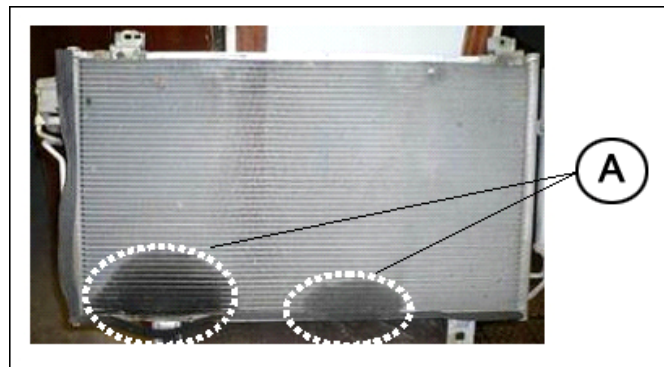
4. Visually inspect the condenser for A/C refrigerant leak. Is there a visible trace of A/C refrigerant leak at location (A)?

- Yes - Go to A. Repair Procedure.
