Cold Start Misfire and/or Rough Idle – DTC P0300 May Be Set

This Bulletin replaces PIP4959G. Please discard PIP4959G.

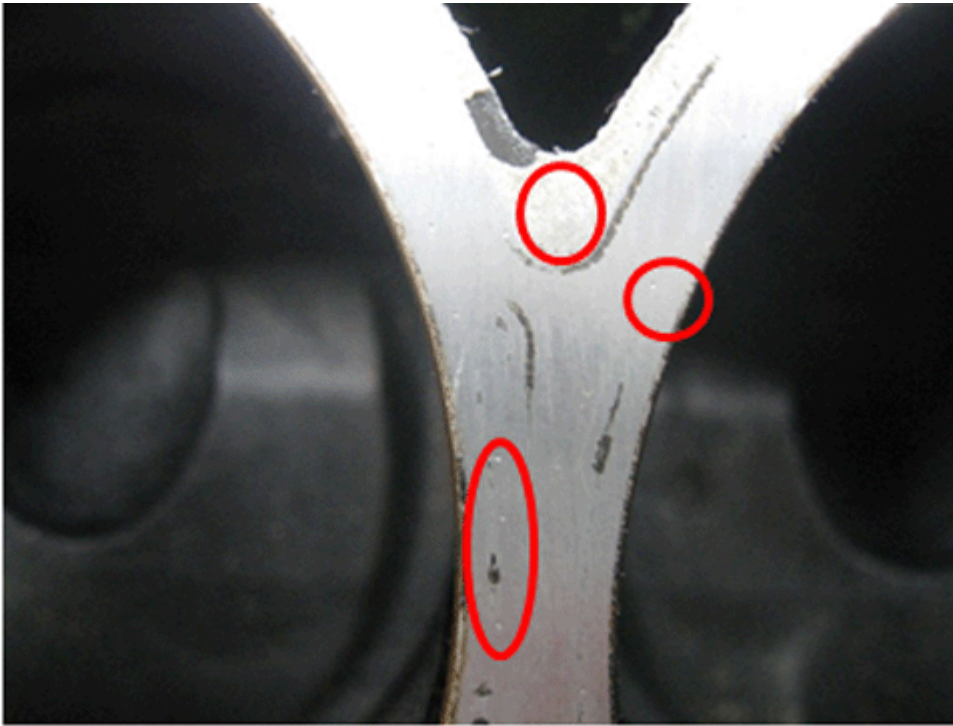
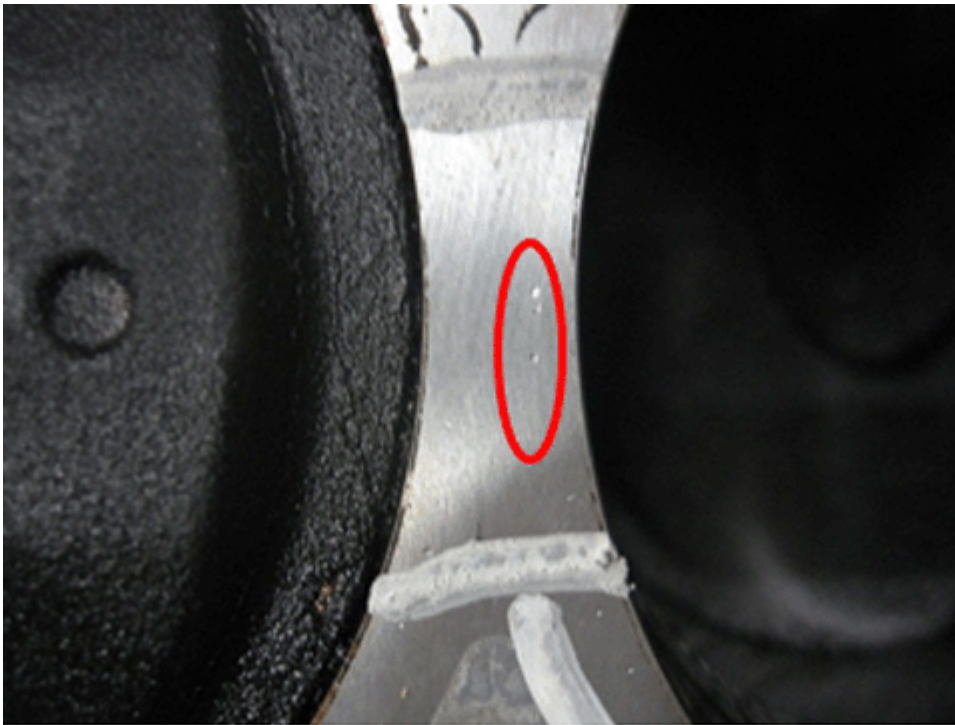
Small surface pock marks or pitting appearance on the deck surface is normal and an engine should not be replaced for any such appearance marks as they do not connect to the engine coolant passages and cause a leak path that will generate engine misfires.

With the cylinder head removed, perform a visual inspection. Reference the following pictures provided. The first two pictures represent normal examples of deck pitting and the cause of the misfire and/or rough idle condition.

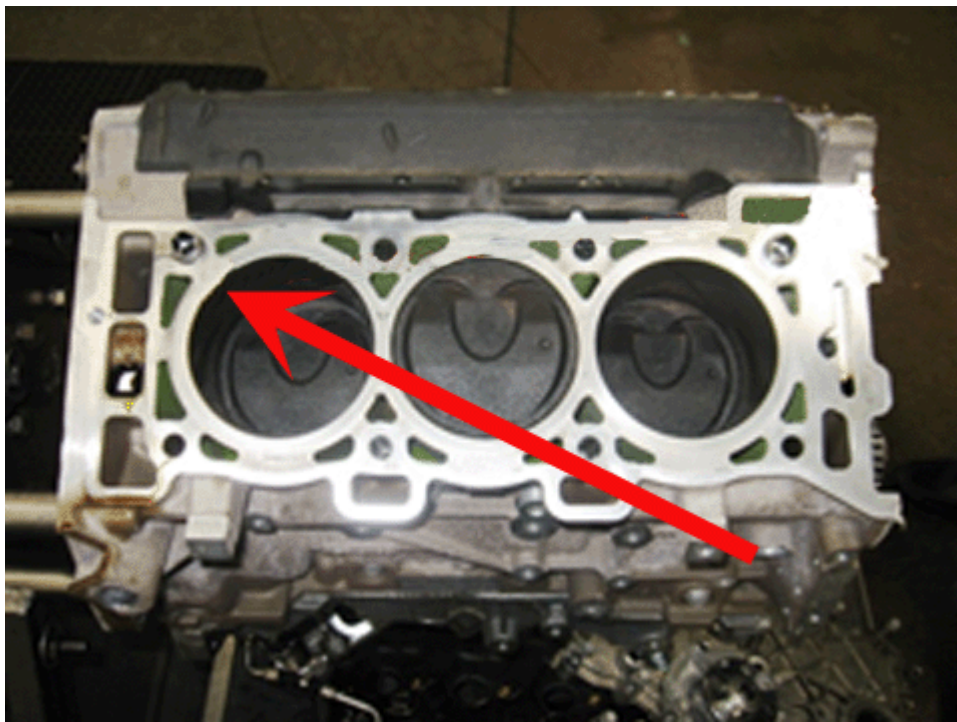
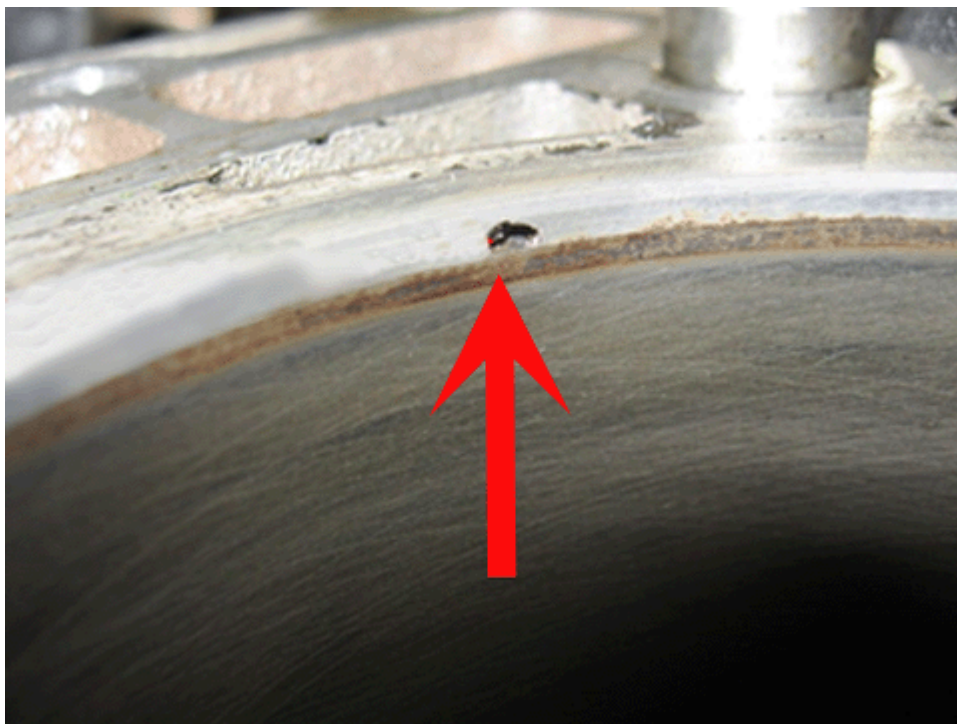
7. The two following pictures represent an example and the location of how actual engine cylinder block porosity appears. This would be a cause of the condition.

This porosity condition is rare, therefore the technician should inspect the suspect cylinder(s) and look for a break/pinhole in the carbon ring area.

Shown at the deck face to cylinder liner interface location is an area of engine cylinder block porosity that has caused an engine coolant leak path into the cylinder causing medium to high misfire counts when the engine is cold.

- If this condition is verified, the engine be replaced.
