06-001/17 - LEATHER STEERING WHEEL SURFACE WEAR / PEEL

TSB NUMBER: 06-001/17

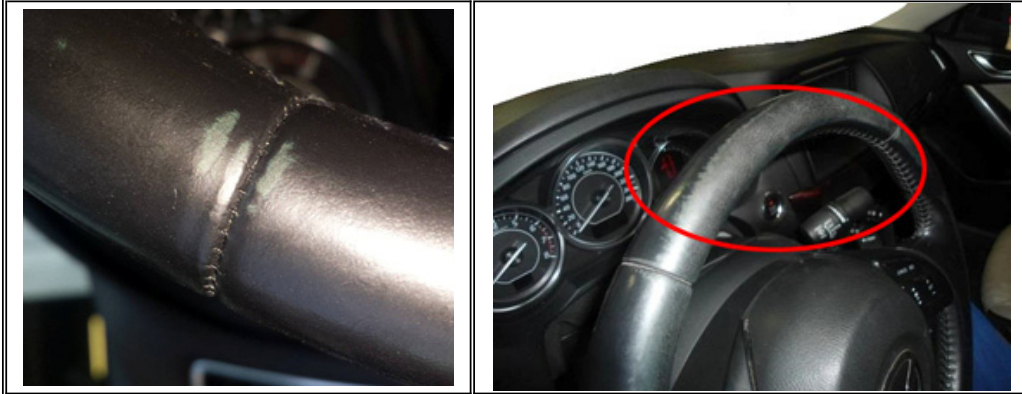
Some vehicles may exhibit wear/peel-off of the leather steering wheel surface causing a poor appearance. This concern may be caused by an insufficient wear resistance of the steering wheel surface.

Mazda6 is shown as an example

Customers having this concern should have their vehicle repaired using the following repair procedure.
