GENERAL SERVICE BULLETIN

Power Running Board (PRB) Deployment Concerns - Grinding Noise, Auto Reversal And/Or Stopping In Mid-Travel

**18-
7081**
05
December
2018

Ford 2015-2019 F-150
2017-2019 F-Super Duty
2015-2019 Expedition
Lincoln 2015-2019 Navigator

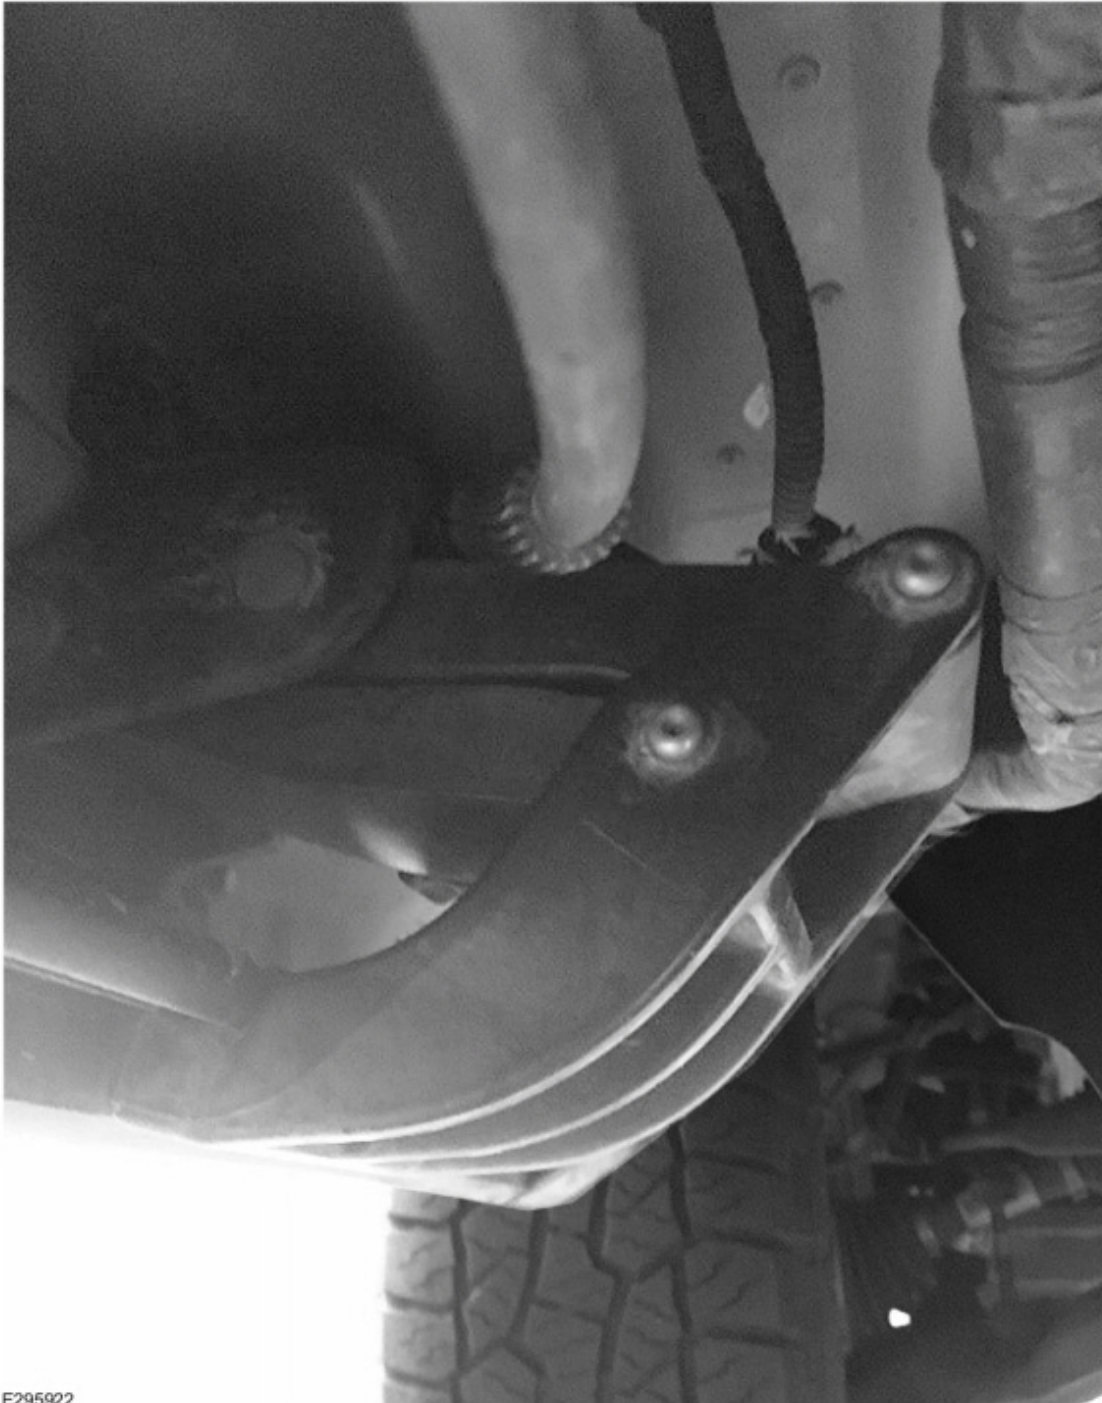
Figure 2

Clean running board after pressure washing (Figure 2)

If there is dirt/debris buildup, clean between the links and bushing ends/tracks using high-pressure water. The use of a car wash wand is best to prevent excessive water pressure from damaging nearby components.

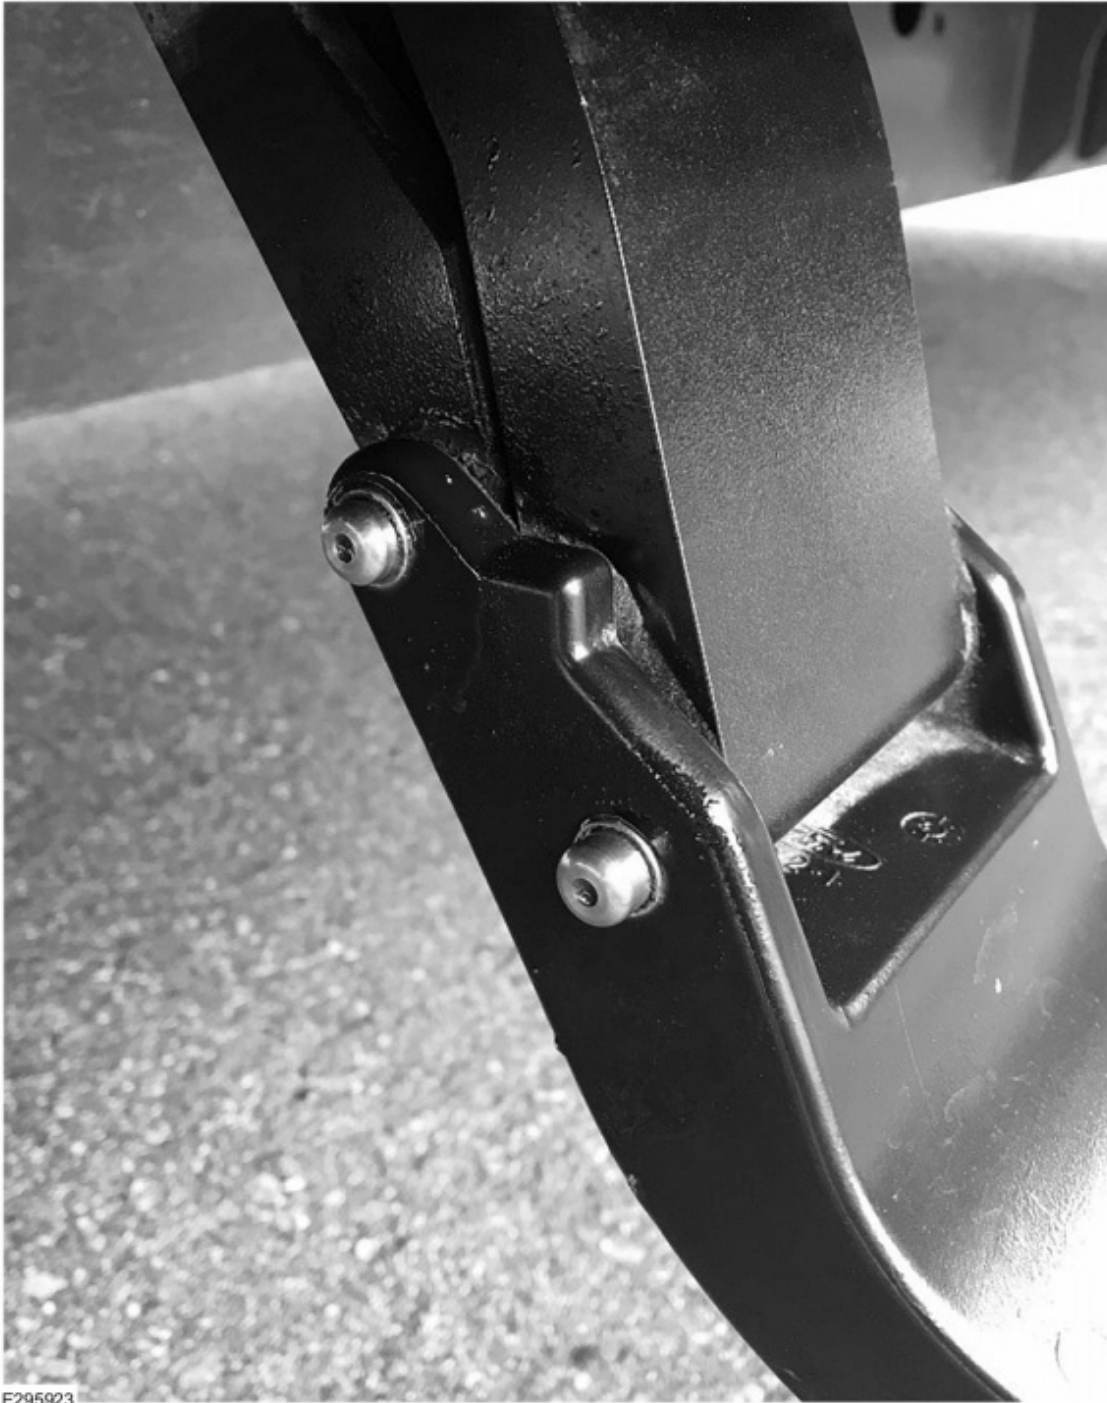
Figure 3

Example of using the penetrating and lock lubricant (Figure 3)

Using a penetrating grease like Motorcraft® Penetrating and Lock Lubricant to clean the bushing locations of both running board hinges. This will help remove any embedded rust/debris that pressure washing may not have removed. If any leftover debris/rust is present after using the penetrating grease, use a pressure washer once more to help remove it.

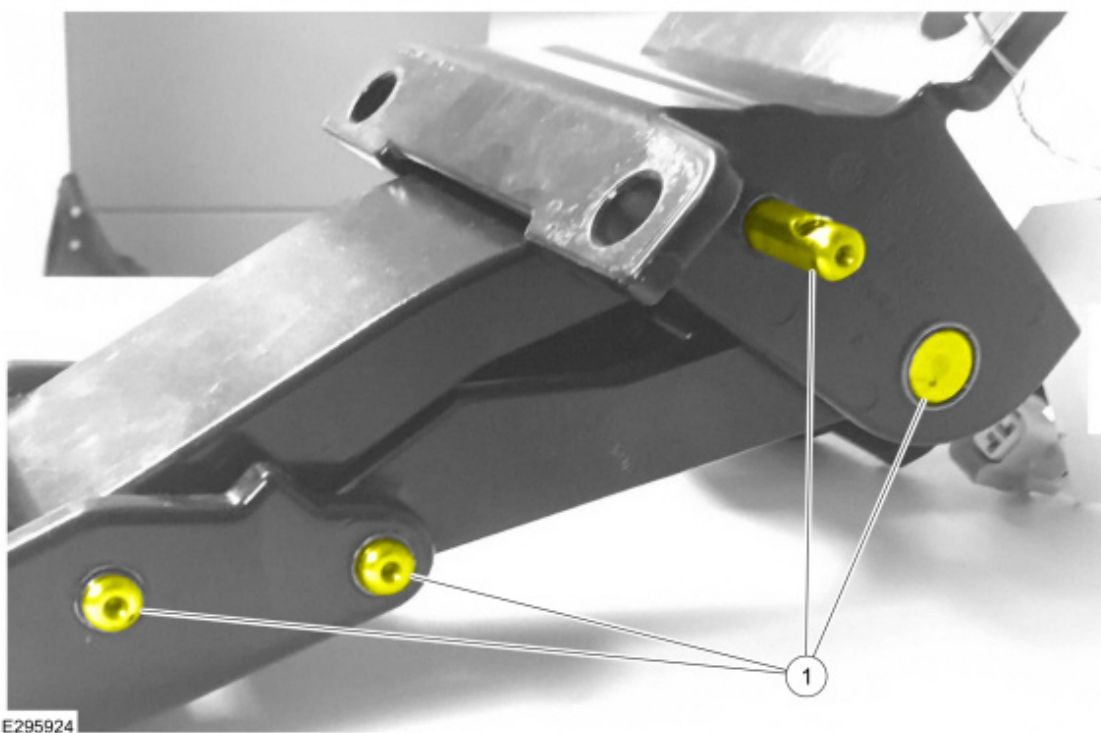
Figure 4

Four bushing locations shown. (Figure 4)

To help prevent power running board deployment concerns in the future, using a lithium grease can help to keep debris away from the moving parts of the running board. Use Motorcraft® Multi-Purpose Grease on each bushing location.
